Manhole Inspection Summary

Manhole # S17W__023MH

Insp Date: **6/24/08 1:12 PM**

Location Address: **1601 harman av**

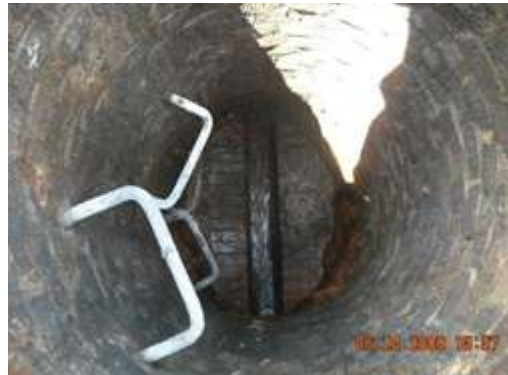
Top View

Comments **significant deterioration & infiltration of the barrel**

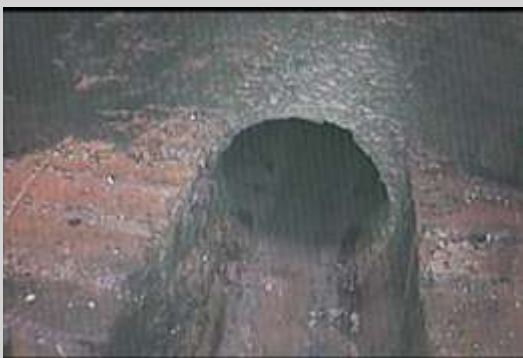
6 O'Clock Inflow

Pipe Height: **8.4** (in.) Rod and Bar (Angled)
Pipe Material: **Clay** ☐ Pipe Lined
Invert Depth: **10.38** (ft.) Flow Characteristics: **Slow**
Deposits: ☒ None ☐ Mud ☐ Sludge ☐ Debris ☐ Grease
Silt Depth: **0** (in.) Deposits Extent:
Infiltration: **None** Pipe Seal Cond: **Unknown**
